Enhancing Weld Inspection Through Image Processing: Detecting Defects in Radiography Films

Keywords: Image Processing, Radiography Film, Weld Deficiencies

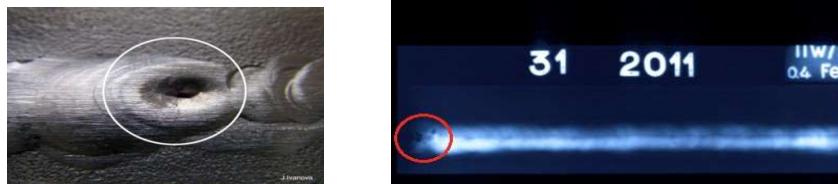
Figure 4. The accompanying radiography film image defines the end crater and star crack.

End craters happen when the welder pulls their hand to remove the electrode, and the weld needs to be filled to the designated weld level. Usually, the end crater has a star fracture that needs to be fixed before filling the hole. According to standards, incomplete penetration happens at the weld's root and is rejected in any size. The margins of the incomplete penetration remain sharp, and a thin black line may be seen in the middle of the weld on the radiography film since it can only occur in the roots. Undercutting happens at the weld face,

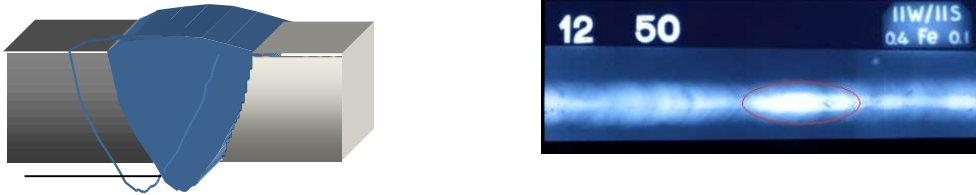
Figure 8. The radiography film image of excess penetration

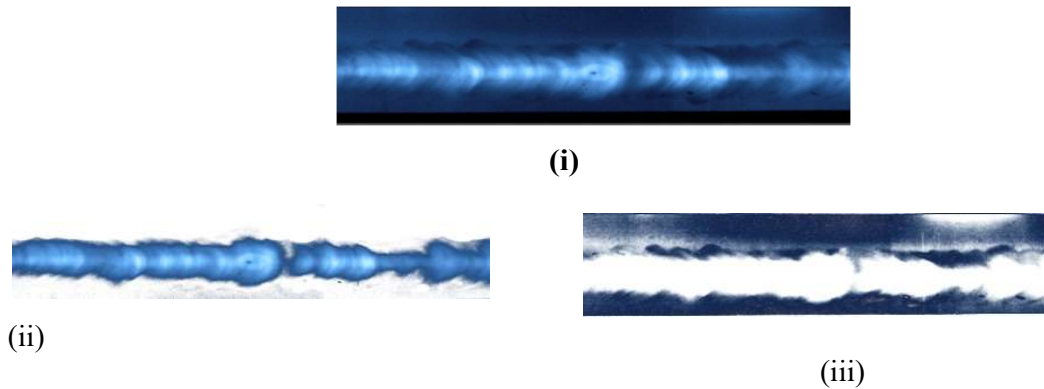
Figure 15. (i) Radiography film (ii) the weld inside cluster (iii) weld side cluster

The defects of the weld edge include undercut, overlap, and faults that should be addressed during visual inspection. The defects of the weld surface include cracks, a lack of fusion, gas porosity, burn through, end craters, and weak arc starting. The weld root's flaws include cracks, porosity, excessive root penetration, lack of penetration, and lack of fusing at the root. If imperfections exist, they will be seen in the middle of the welding process in the radiography film image. To find weld flaws, the three previously mentioned regions should be separated into clusters and then checked individually. Figure 15. shows the radiography film image (i), the weld inside the cluster (ii), and the cluster of the weld side that was split by clustering (iii). as shown in figure 16. The weld edge cluster and matching radiography film are displayed.

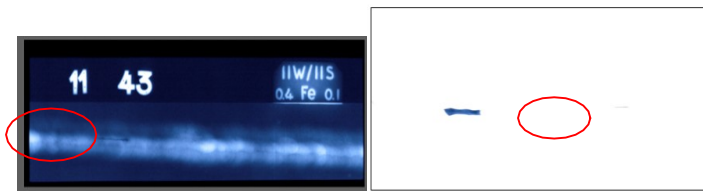
Figure 17.Image from radiography film and cluster of additional weld metal

Figures 17 through 25 display the findings from flaw detection and clustering. They are distinguishable from one another because of the shape and size of the weld flaws. Figure 17 displays the surplus weld metal cluster image as well as a radiography image. In Fig., excess weld metal due to higher density that is more visible in the film is indicated in red. A radiography film image and the images of the end crater, fracture, porosity, and burn through are displayed in Figs. 18 to 21, respectively. Because the welded portion is darker than the remaining portions, there is a reduced volume of metal that can cause cracks, porosity, burn through, incomplete fusion, and end craters. Cracks can appear in vertical or horizontal lines. Gas porosity has a tiny, spherical shape. It is possible to distinguish between burn through and end crater defects in terms of their morphology and image processing. Diagnosing burn through from end crater can be challenging at times. If end crater is

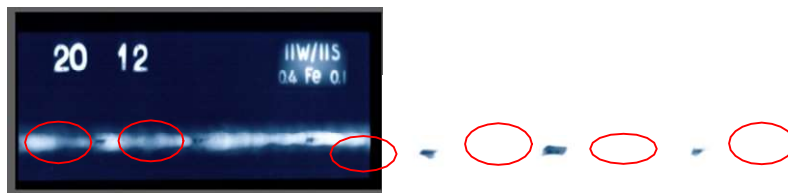
Figure24.The radiography film image and the cluster of extra penetration

found in the weld surface but burn through extends to the weld root, referring to the root can aid in detection. Weld shape investigations show that when there are faults in the weld edges, the weld edges go to the inside in an undercut. The edge is a flat line in incomplete fusion, denoting that the edge of the base metal has not melted. The weld line's edge strayed towards the part side. The radiography film image and the cluster of the weld edge in the event of an incomplete fusion and undercut are displayed in Figs. 22 and 23. Regarding the root flaws, a radiography film image and the cluster of incomplete and excess penetration are displayed in Figures 24 and 25. Images clearly show the distinction between the two flaws.
